NASA Project Mercury Working Paper No. 192

POSTLAUNCH REPORT

MERCURY-REDSTONE NO. 3

June 16, 1961

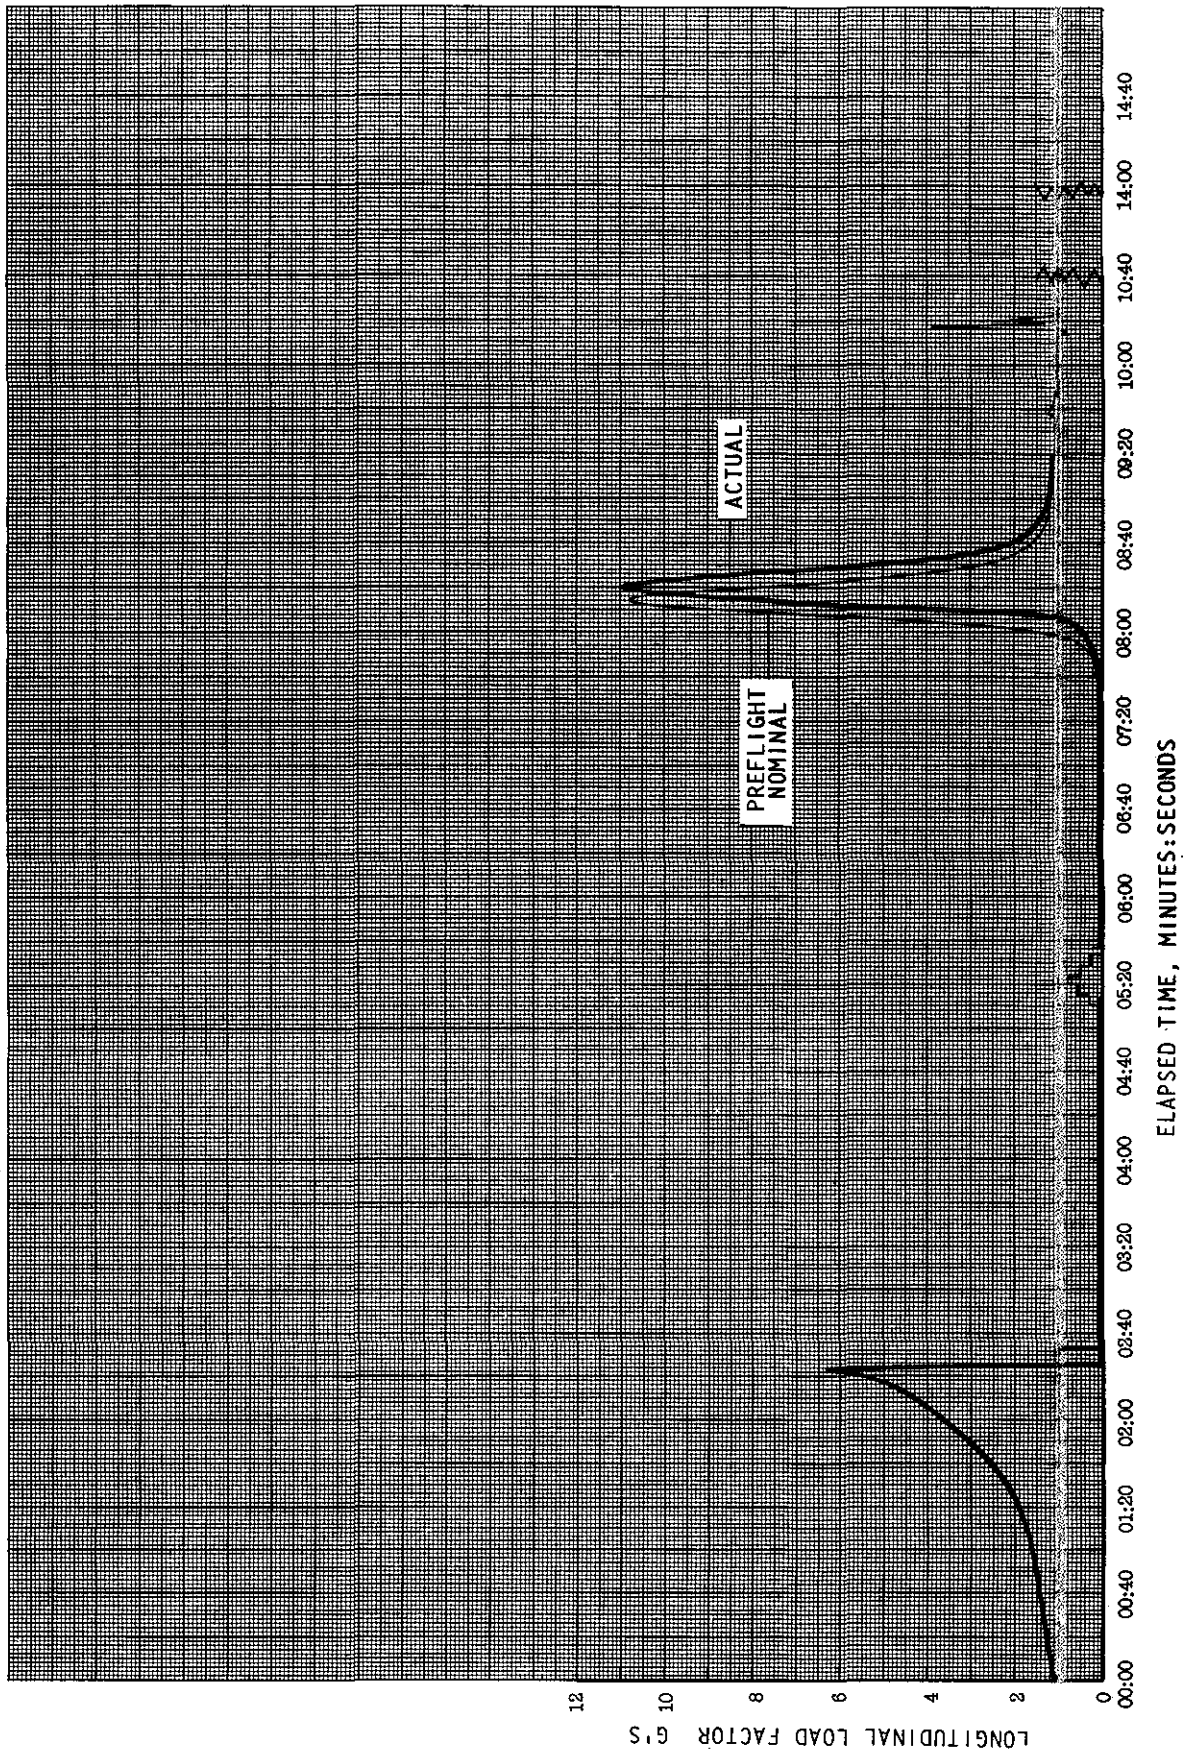
FIGURE 4.2-5.- TIME HISTORY OF LONGITUDINAL LOAD FACTOR.

The longitudinal acceleration data are presented in Figure 4.2-5. During exit the acceleration increased from about 1.15g at lift-off to a value of 6.3g, which occurred at booster cutoff (02:22). The acceleration then decayed to zero, and remained at zero for slightly over five minutes with the exception of periods of posigrade rocket firing at about 02:31 and retrorocket firing at about 05:14. The first measurable acceleration during reentry occurred at 07:48. The acceleration increased to a peak value of 11g at 08:21. Accuracy of acceleration data measurement would not permit determination of magnitudes for posigrade rocket firing, retrograde rocket firing, and drogue parachute deployment. Main parachute deployment resulted in an acceleration of about 4g. The normal and lateral accelerations were small throughout the flight.

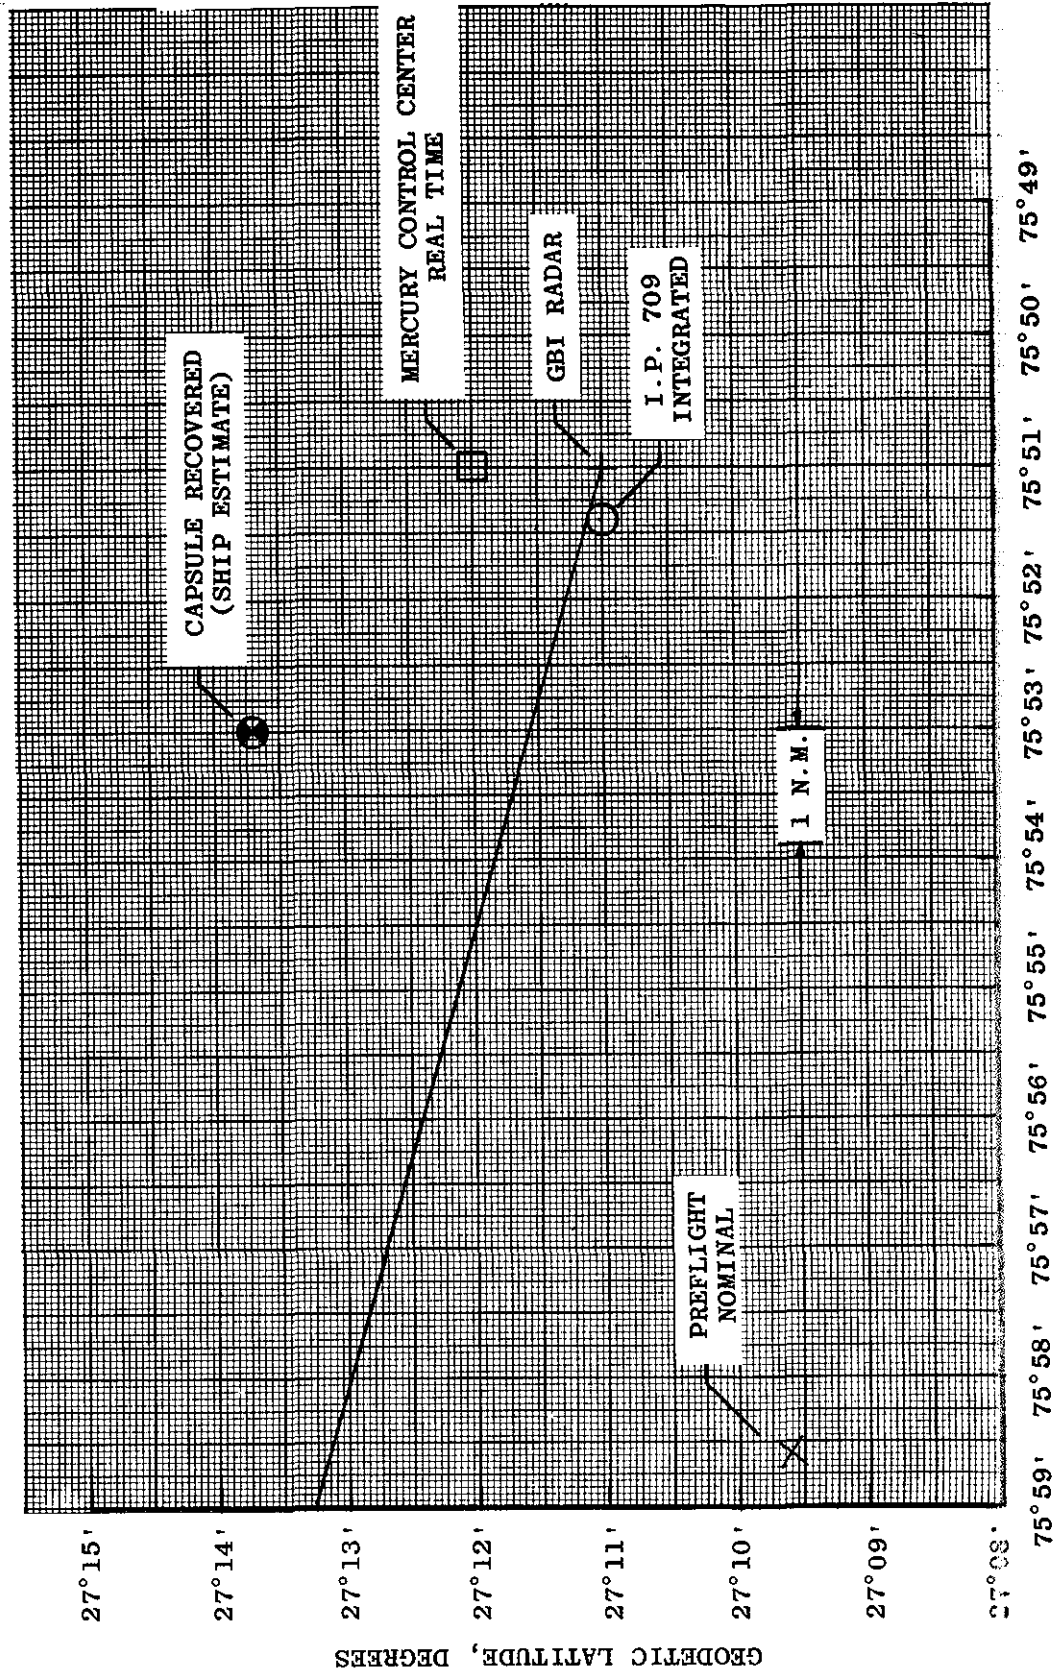
FIGURE 4.2-10.-COMPARISON OF LANDING POINTS COMPUTED BY VARIOUS METHODS WITH ACTUAL LANDING POINT.

The various predictions of impact point are compared with actual capsule recovery point in Figure 4.2-10. As can be noted from the figure, the actual recovery point as estimated by the recovery ship differs from the pre-flight nominal by 6.2 miles, and the Mercury Control Center real time prediction by 3 miles.
